Student Medical and Counseling Center

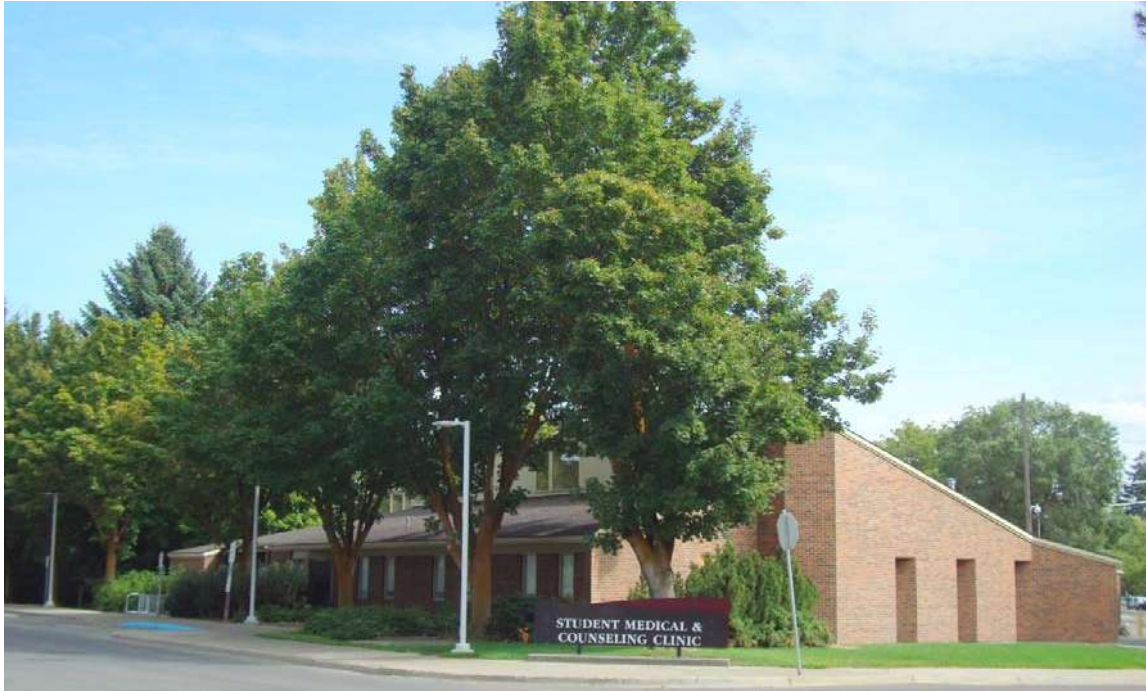
The Student Medical and Counseling Center (Figure 8.73) was completed in 1970 in a Late Modern style. The unit massing of the building is single and detached. The plan is irregular. The roof is a skillion and lean-to form with composite shingling. No chimneys are noted. There are six separate attic spaces noted in the original architectural drawings (A.O. Bumgardner and Partners Architects 1970). There is a crawlspace, but no basement.

The exterior wall material is brick in a stretcher bond. The exterior wall design is flush. A sloped header brick trim, similar to the slip sills of the main windows, lines the top of the wall below a wooden frieze under the eave of the lean-to roof. The corners of the buildings are at obtuse and acute angles, an architectural design common in the 1970s.

Figure 8.73. Student Medical and Counseling Center in 2014, looking southeast. (Photograph taken by Lauren Walton).

All windows have a flat structural opening. The typical window is a square sliding or fixed window with plain trim, a header brick slip sill, and no surround. A clerestory lines the north face of the skillion roof just above the lean-to. Three vertically rectangular windows on the west face are deeply set in structural openings that face southwest. Entrances are single leaf, solid wood doors, or they are single or double leaf, single panel glass and wood doors. Doors have no trim or surround. Non-public access doors are located on the west and east faces. The main entrance to the medical clinic side was located in an umbrage on the north face, but this entrance is no longer in use. The main entrance to the counseling clinic side has become the only public entrance, and is located on the southwest face of the building under the eave of the roof. Louvers, a slender rolling metal door, and service doors are located on the west and south faces just south of the main entrance. A patio with a privacy fence is located on the south side of the building, to

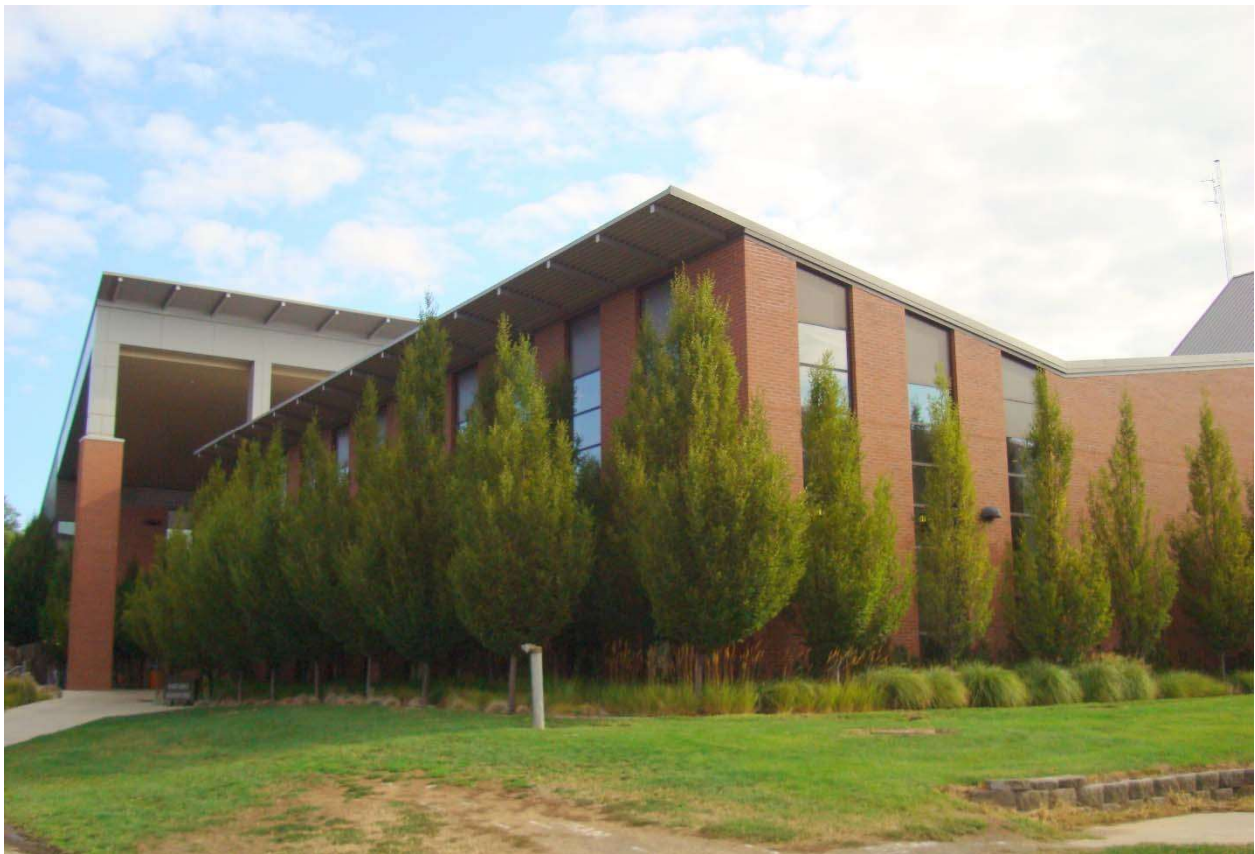
The Student Union and Recreation Center (SURC) (Figure 8.74) was opened in 2007, though

Figure 8.74. Student Union and Recreation Center in 2014, looking northeast. (Photograph taken by Lauren Walton).
